WL-TR-92-4079

## Internal Structural Characterization

General Electric Aircraft Engine  
Quality Technology Center  
One Neumann Way  
Cincinnati, OH 45215-6301

Final Report for 09/01/88 - 03/30/92

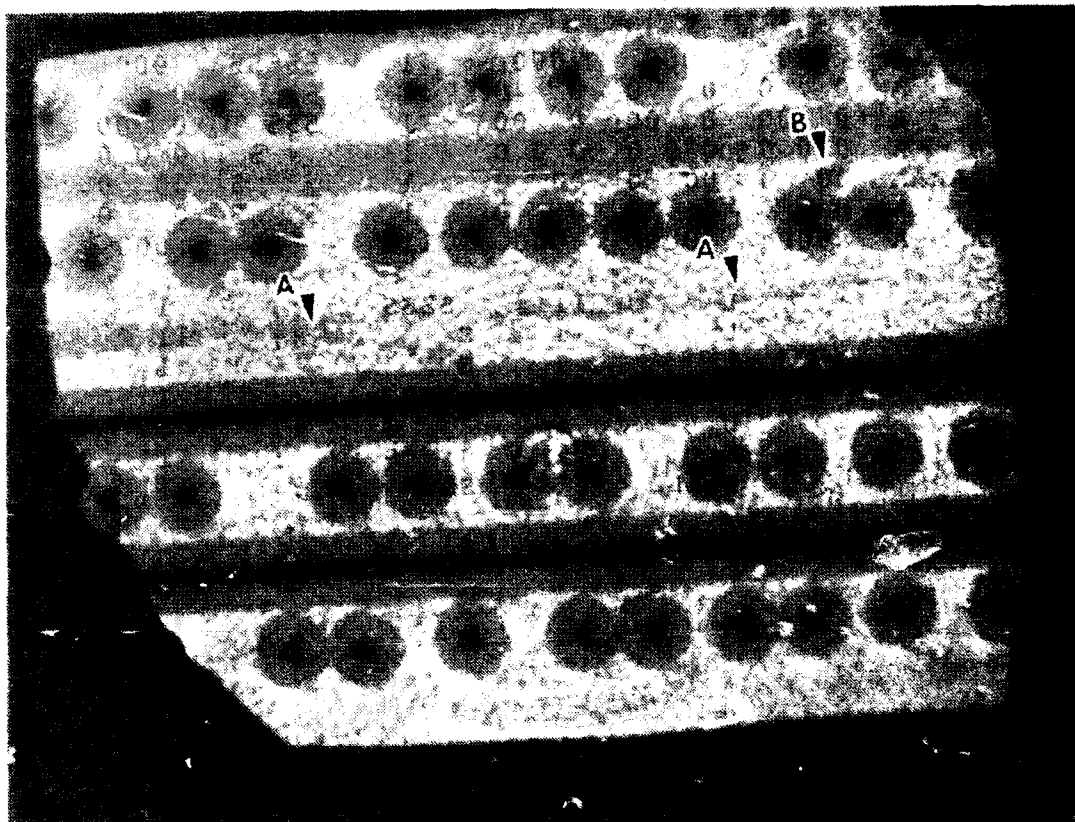
Figure 5.23 Synchrotron image of CAS/SCS-6 system, showing broken fiber and matrix cracks. Arrows A points to a matrix crack traveling the length of the specimen, its maximum width was 1.5 microns. Arrow B points to a broken fiber.

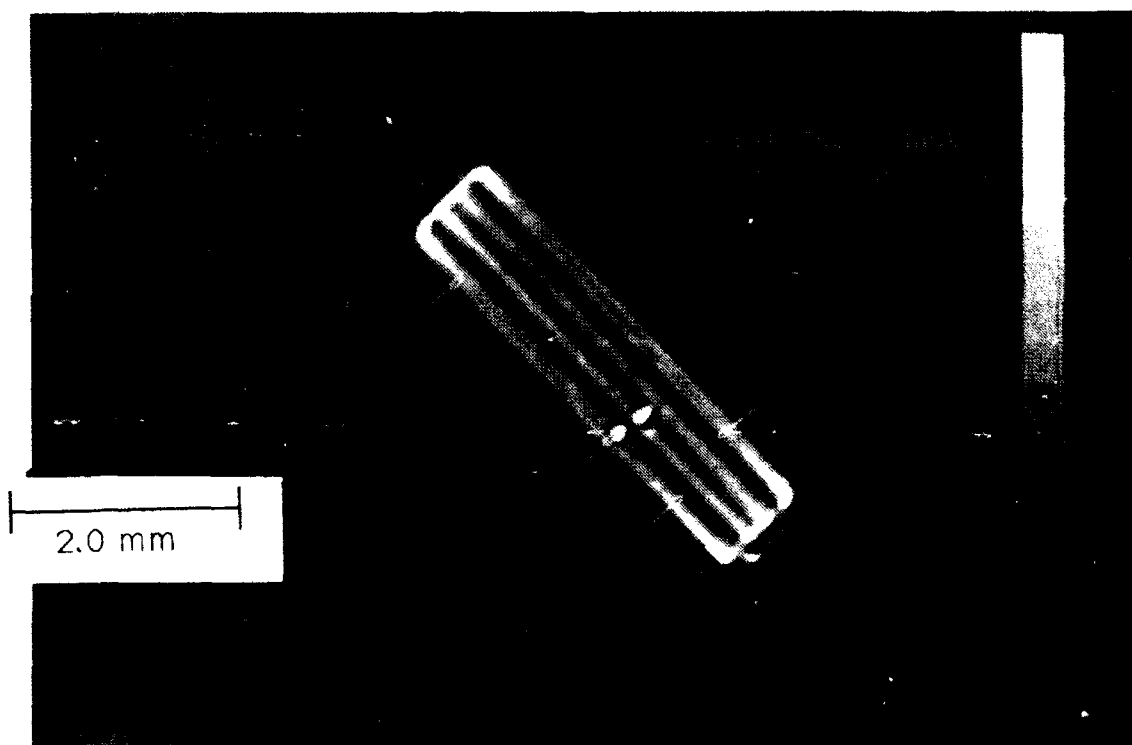
Figure 5.25 Dual Energy image of TiAl/SCS-6 sample: copper equivalent data

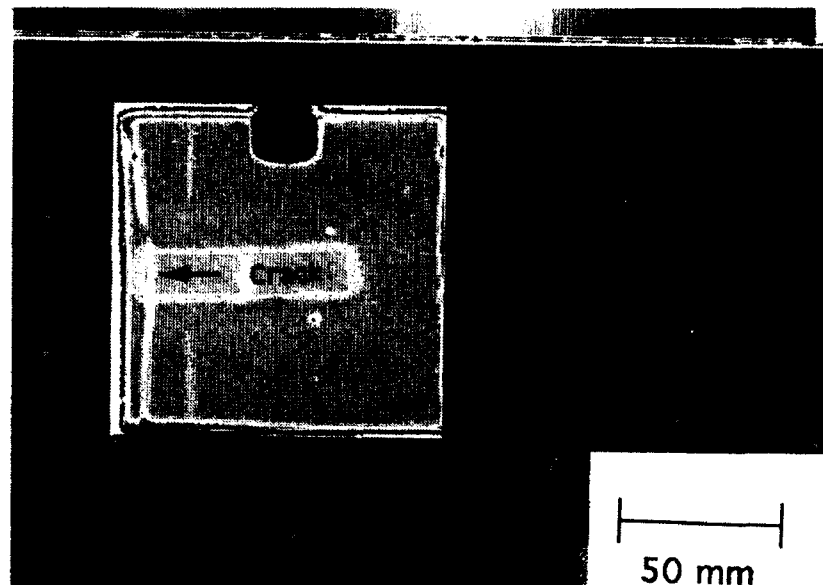
Figure 6.2 Ultrasonic through-transmission attenuation image of CAS/Nicalon CMC panel N11 showing matrix cracks. White vertical indications represent cracks.

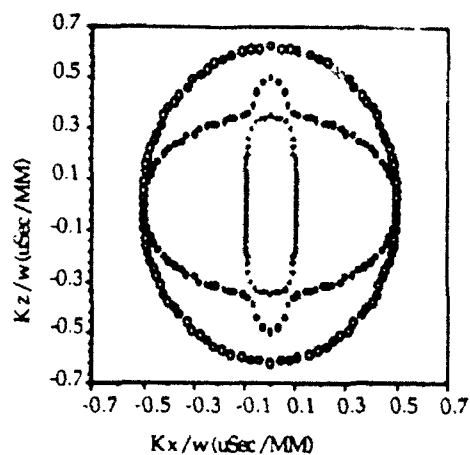
Fig. 3a. Slowness plot for graphite-epoxy - 60% fiber volume fraction at 0° azimuthal angle.

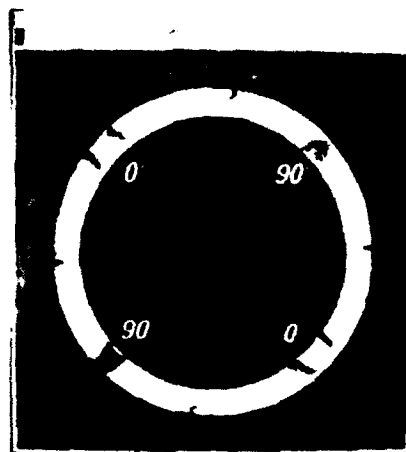
Fig. 7. Polar backscatter scan showing the 0/90° fibers in a [0/90] 4s CAS-Nicalon CMC.

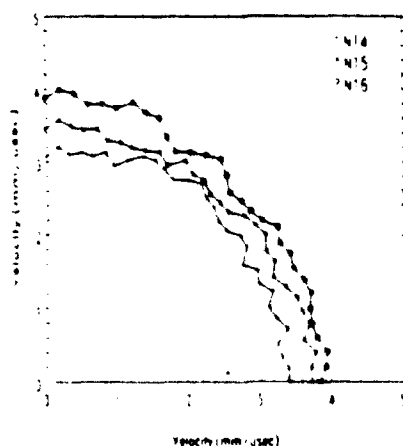
Figure 1. The SAW velocity obtained for the CMC specimens N14, N15 and N16. Each point represents the average of five data points with a standard deviation of 0.04 mm/ $\mu$ sec.

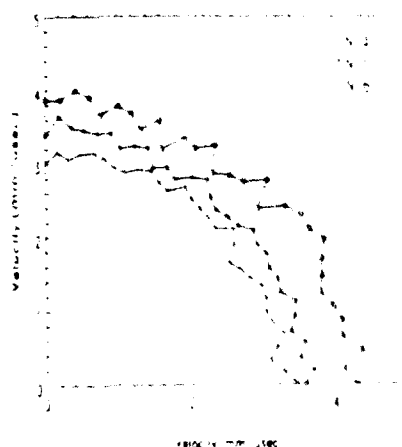
Figure 2. Experimental surface acoustic wave velocity in the X1-X2 plane, obtained by using the contact mode method with a pair of 2.25 MHz transducers, for CMC specimen N14, N15 and N16. Each point represents the average of five data points with a standard deviation of 0.07 mm/ $\mu$ sec.

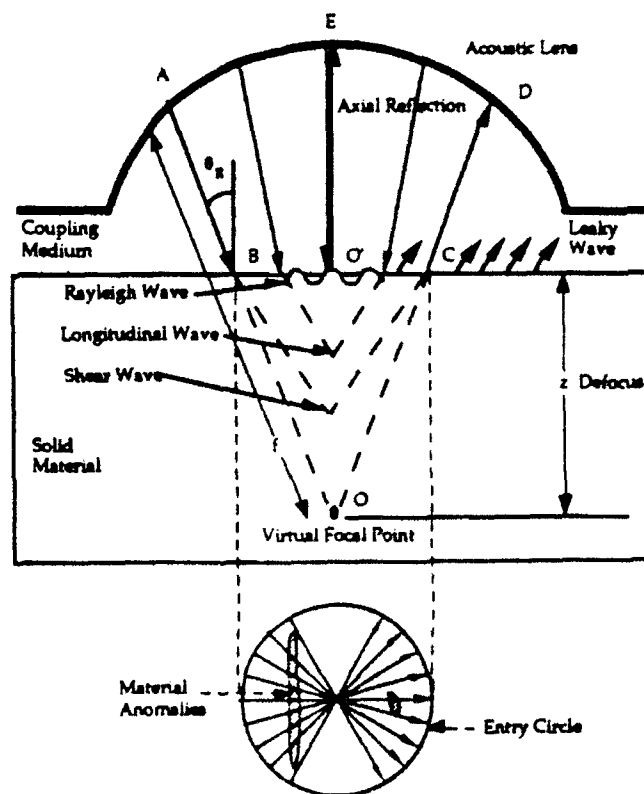
Figure 3. A ray model of the acoustic fields of the converging beam and the axially reflected waves from a highly convergent transducer. The leaky surface wave component is excited by the incident ray at the Rayleigh critical angle  $\theta_R$ .

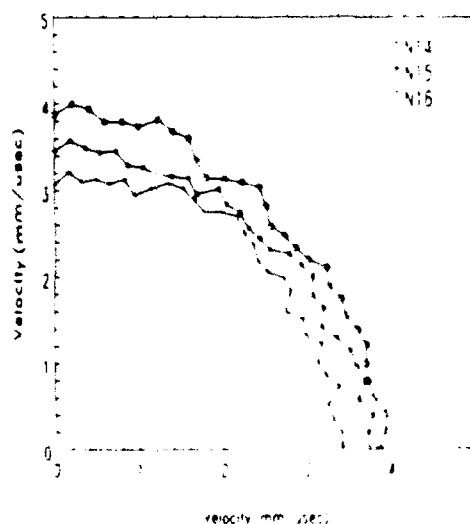
Figure 4. The SAW velocity obtained for the CMC specimen N14, N15 and N16. Each point represents the average of five data points with a standard deviation of 0.04 mm/μsec.
